**DATE:** January 24, 2017

**SUBJECT:** Fire Hall 1 Assessment and Proposed Replacement

To present the results of the Fire Hall 1 condition and functional assessment draft report and to advise on its proposed replacement.

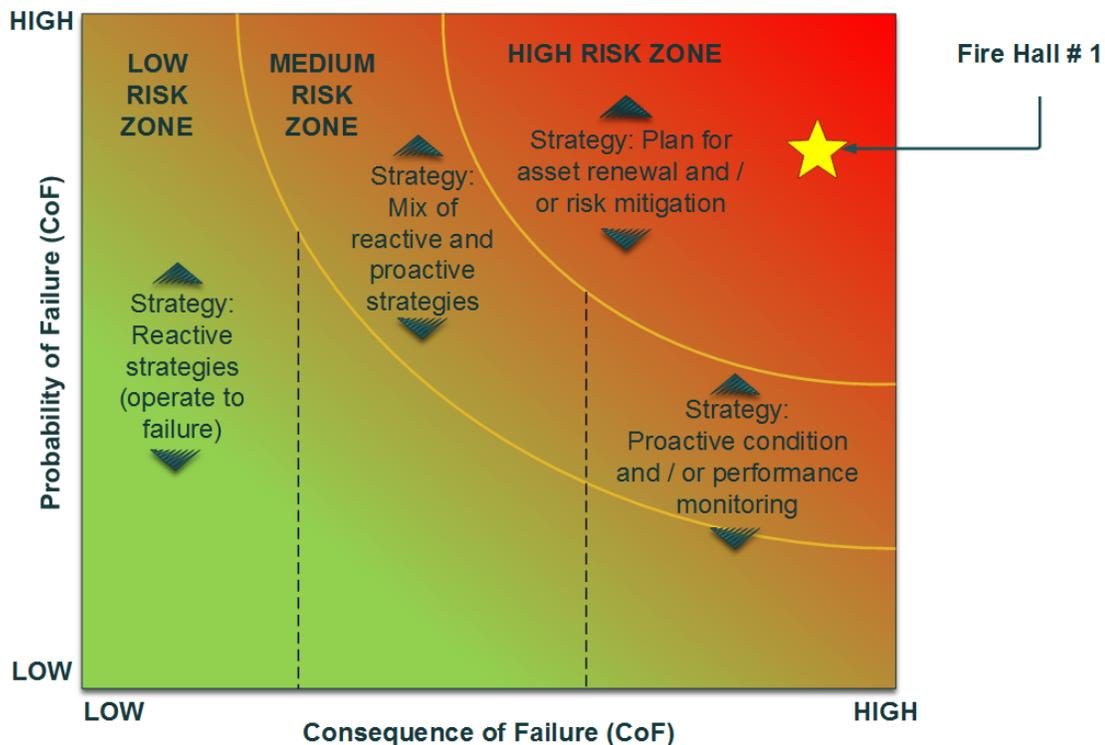
Figure 1 – Facility Risk for Fire Hall 1

Based on a high-level, qualitative assessment of Fire Hall 1’s facility risk according to the City’s Facilities Risk Framework, AECOM determined that Fire Hall 1 falls within the “High Risk Zone”, as presented in Figure 1 below.

The probability and consequence of failure are unacceptable and mitigation measures need to be implemented to reduce the facility risk. Having evaluated the current condition of Fire Hall 1, together with the functionality assessment, AECOM recommends that Fire Hall 1 be replaced.
