# **GEOTECHNICAL OVERVIEW**

**INDUSTRIAL LAND USE PLAN  
PRINCE GEORGE AIRPORT WEST**

**PROJECT No. K-2517**

**JULY 18, 2008**

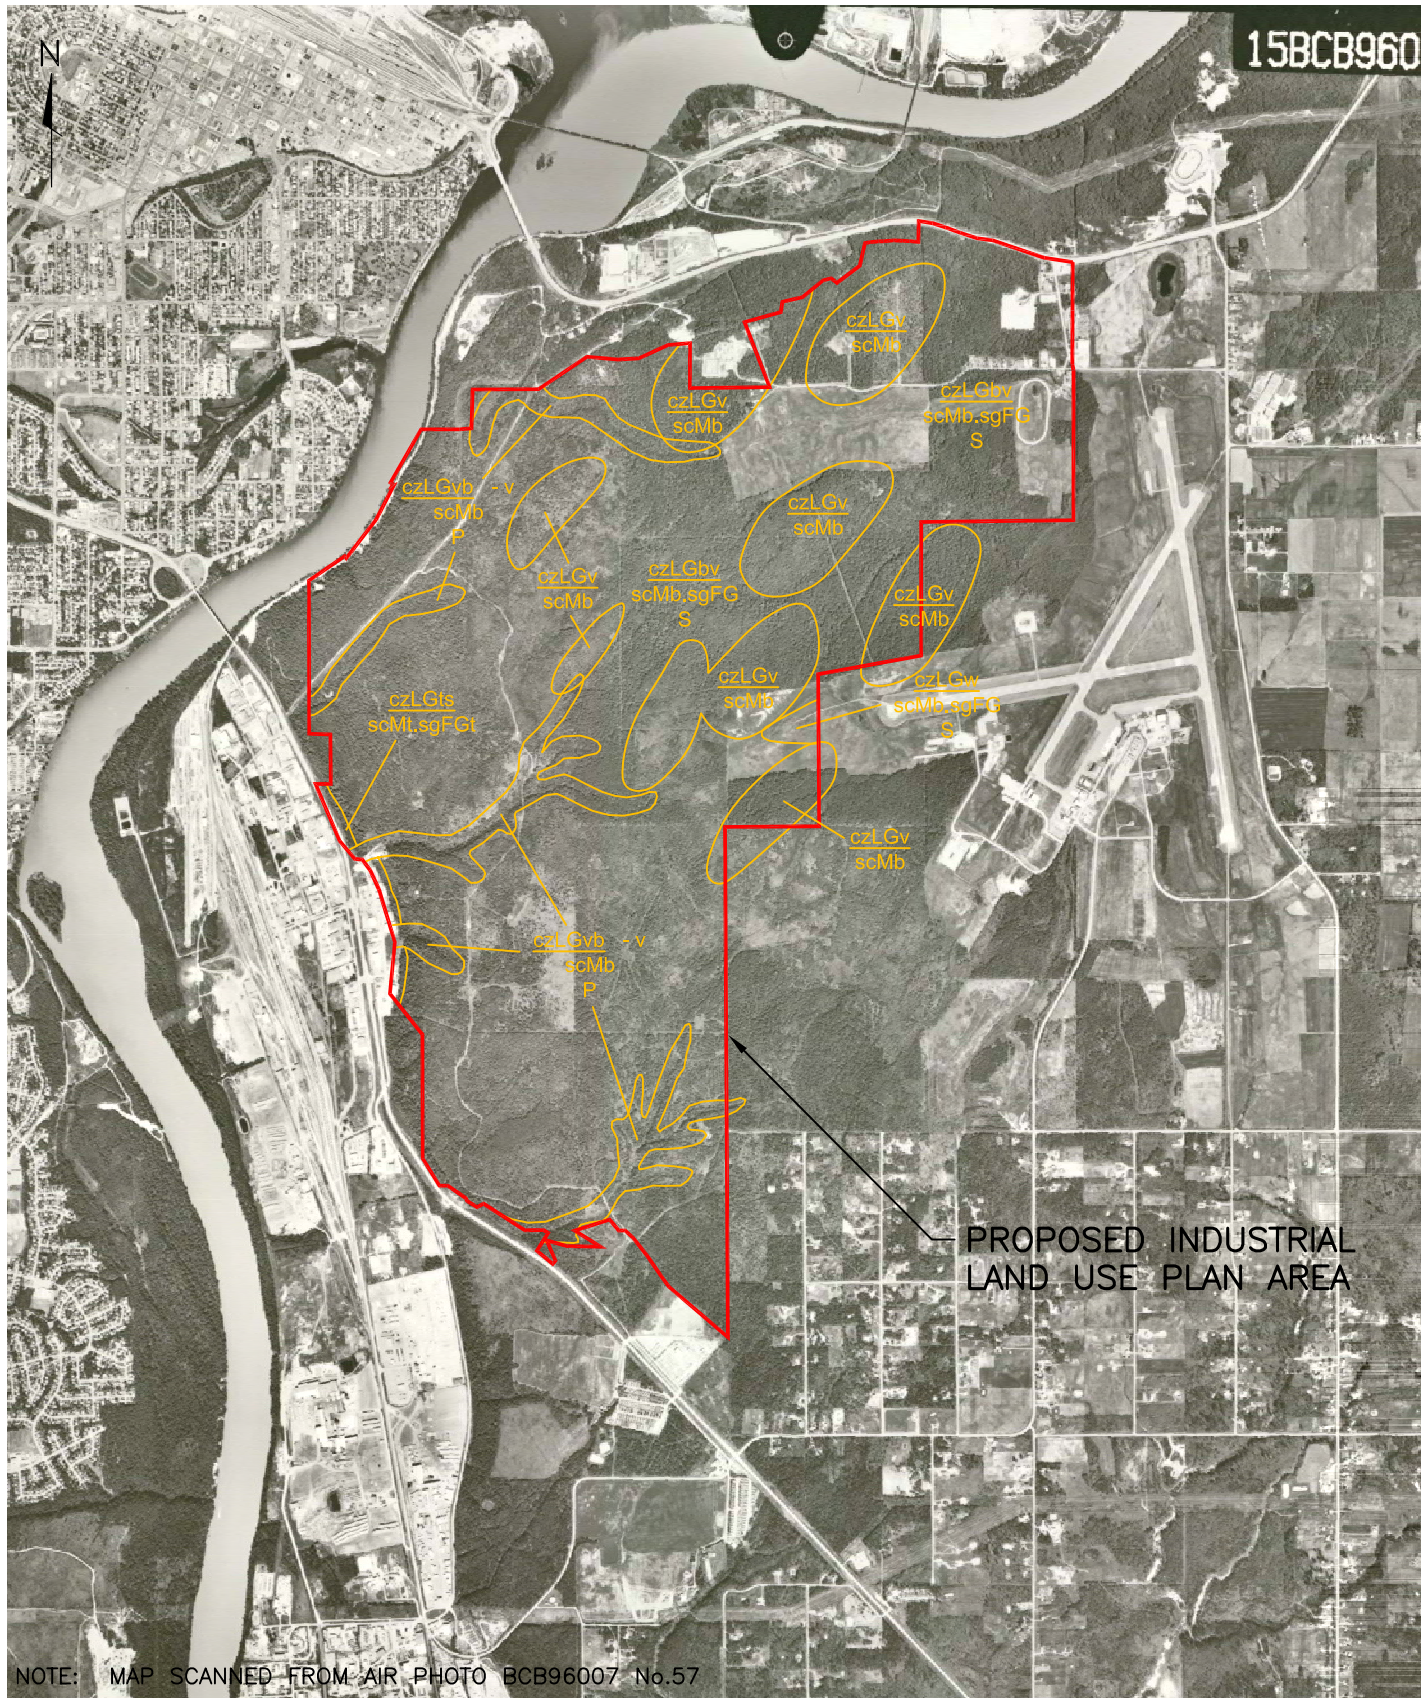
NOTE: MAP SCANNED FROM AIR PHOTO BCB96007 No.57

PROPOSED INDUSTRIAL LAND USE PLAN AREA
